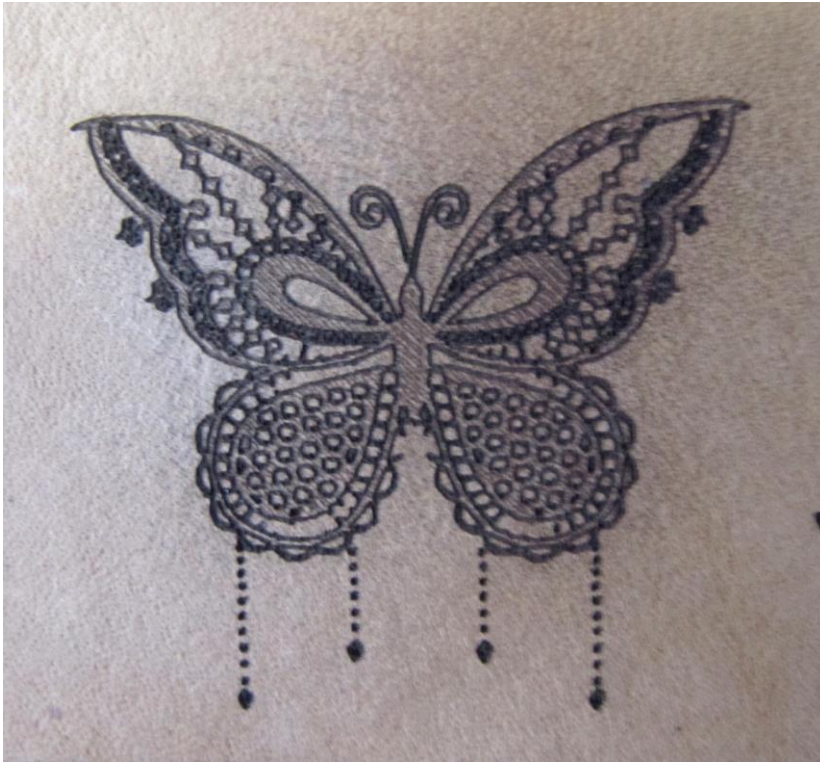
Initially, the machine was working properly and burned so (30*40 mm)

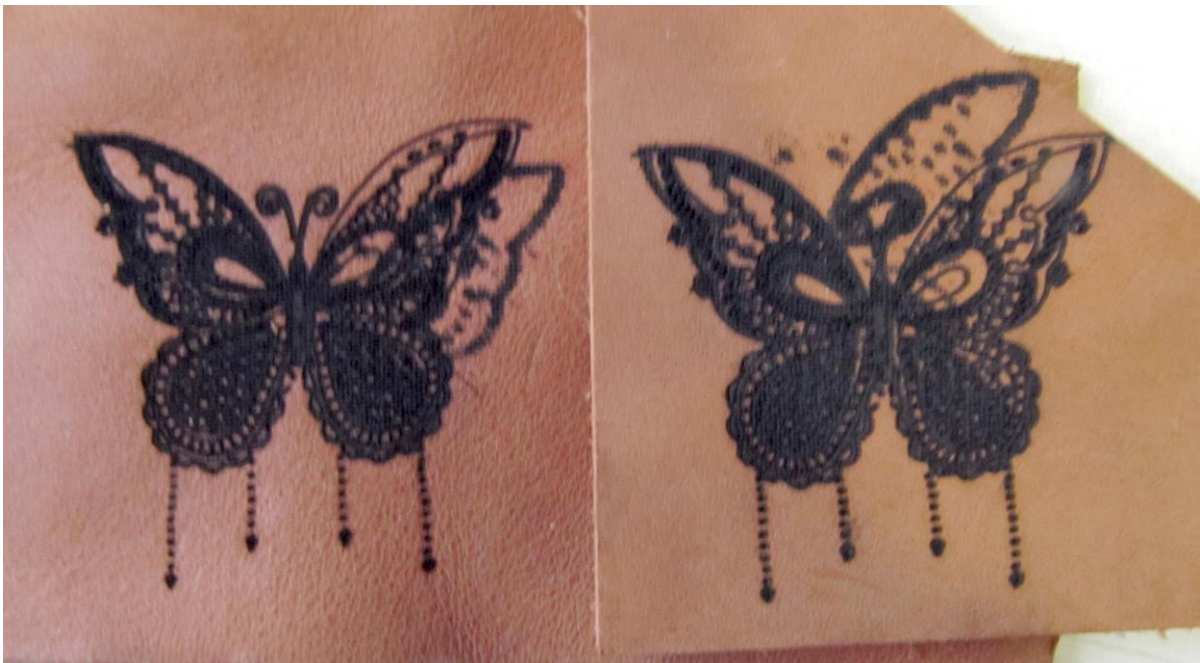
After upgrading, it turns out:

Even if the code does not change, the shift occurs in different places.

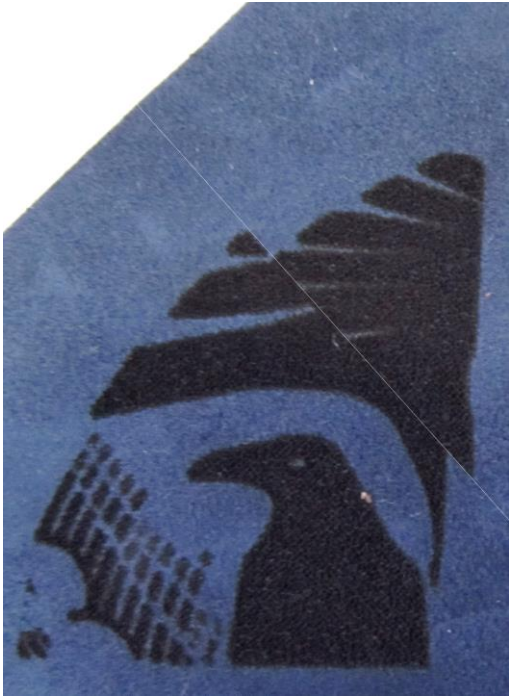
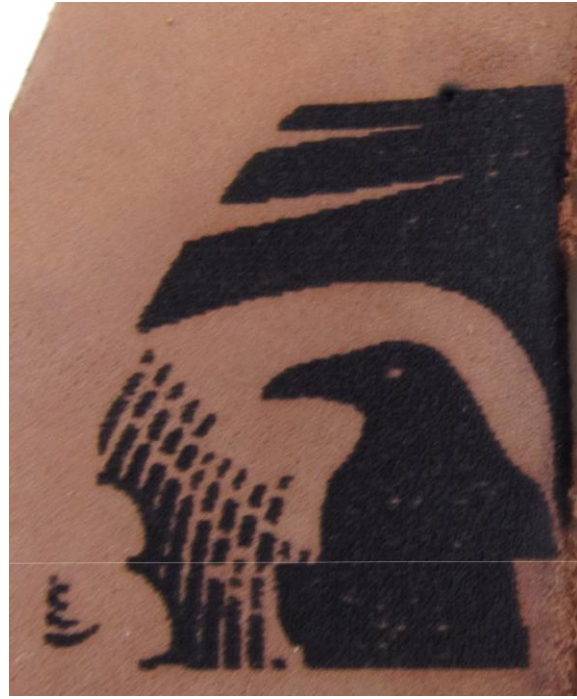
The offset occurs in any mode when filling diagonally and horizontally:

I drew a line offset (20*30 mm)

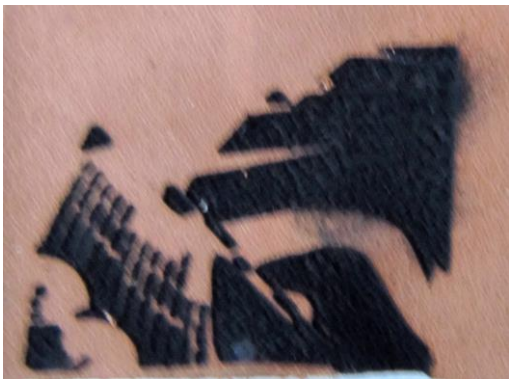
Sometimes even this shift several times in one picture

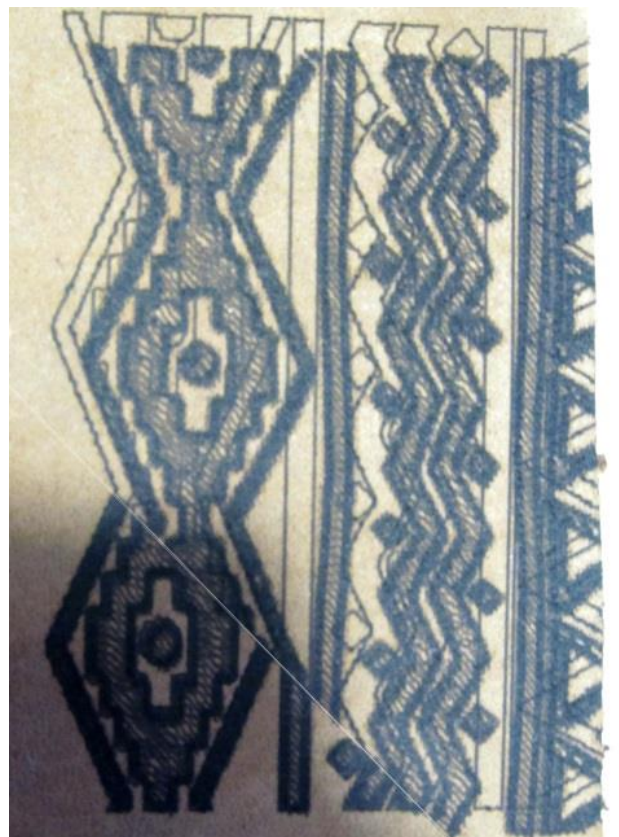
(50*70 mm)

Here you can see that the internal filling were shifted and after that the border is performed correctly:
